H TECHNICAL PROCEDURE

ULTIMAAX® Rear Suspension for Kenworth Vehicles

SUBJECT: Service Instructions

LIT NO: 17730-301

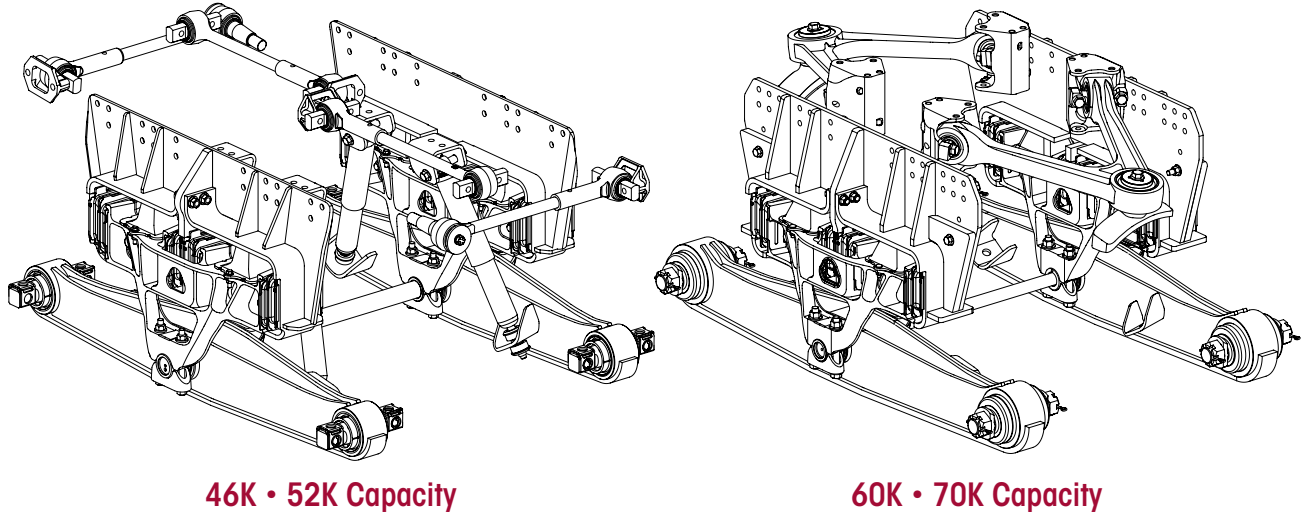
FIGURE 2-1

- **Rubber shear springs** — Primary springs in unloaded condition, providing superb ride quality. React to longitudinal loads during braking and accelerating for minimal displacement.

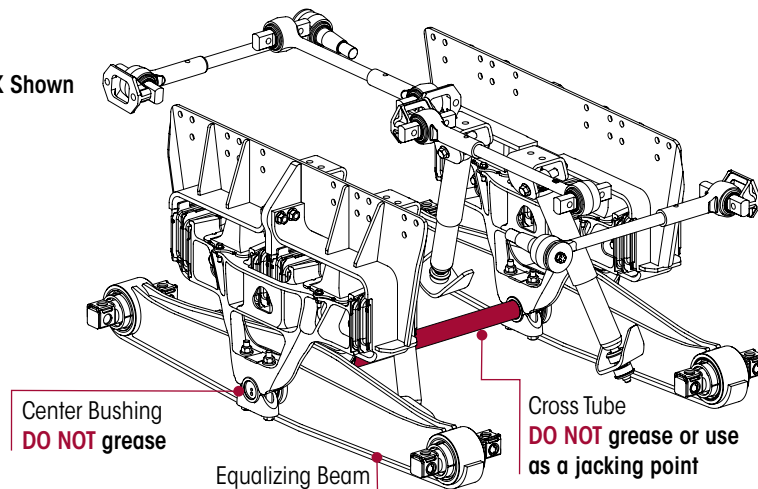
FIGURE 3-1

ULTIMAAX 52K Shown

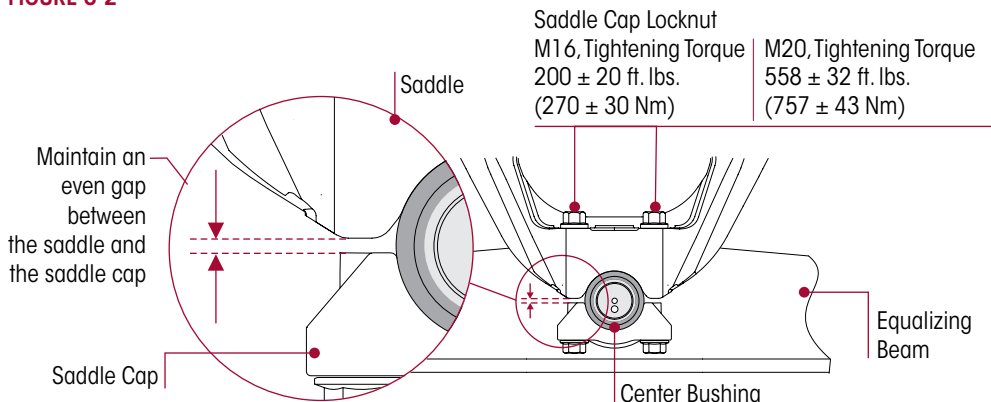
FIGURE 3-2

SADDLE CONNECTION

A SADDLE ASSEMBLY IS ATTACHED TO THE CENTER BUSHING OF EACH EQUALIZING BEAM WITH TWO (2) SADDLE CAPS. EACH SADDLE CAP USES TWO (2) BOLTS TO CLAMP THE CENTER BUSHING INNER METAL TO THE SADDLE. EACH SADDLE CAP MUST BE INSTALLED SO THAT THERE IS AN EVEN GAP BETWEEN THE SADDLE CAP AND THE BASE OF THE SADDLE LEGS AS SHOWN IN FIGURE 3-2. IF EACH SADDLE CAP IS NOT INSTALLED EVENLY, THE SADDLE LEGS COULD BECOME DEFORMED, RESULTING IN BENT BOLTS OR DAMAGED SADDLES.

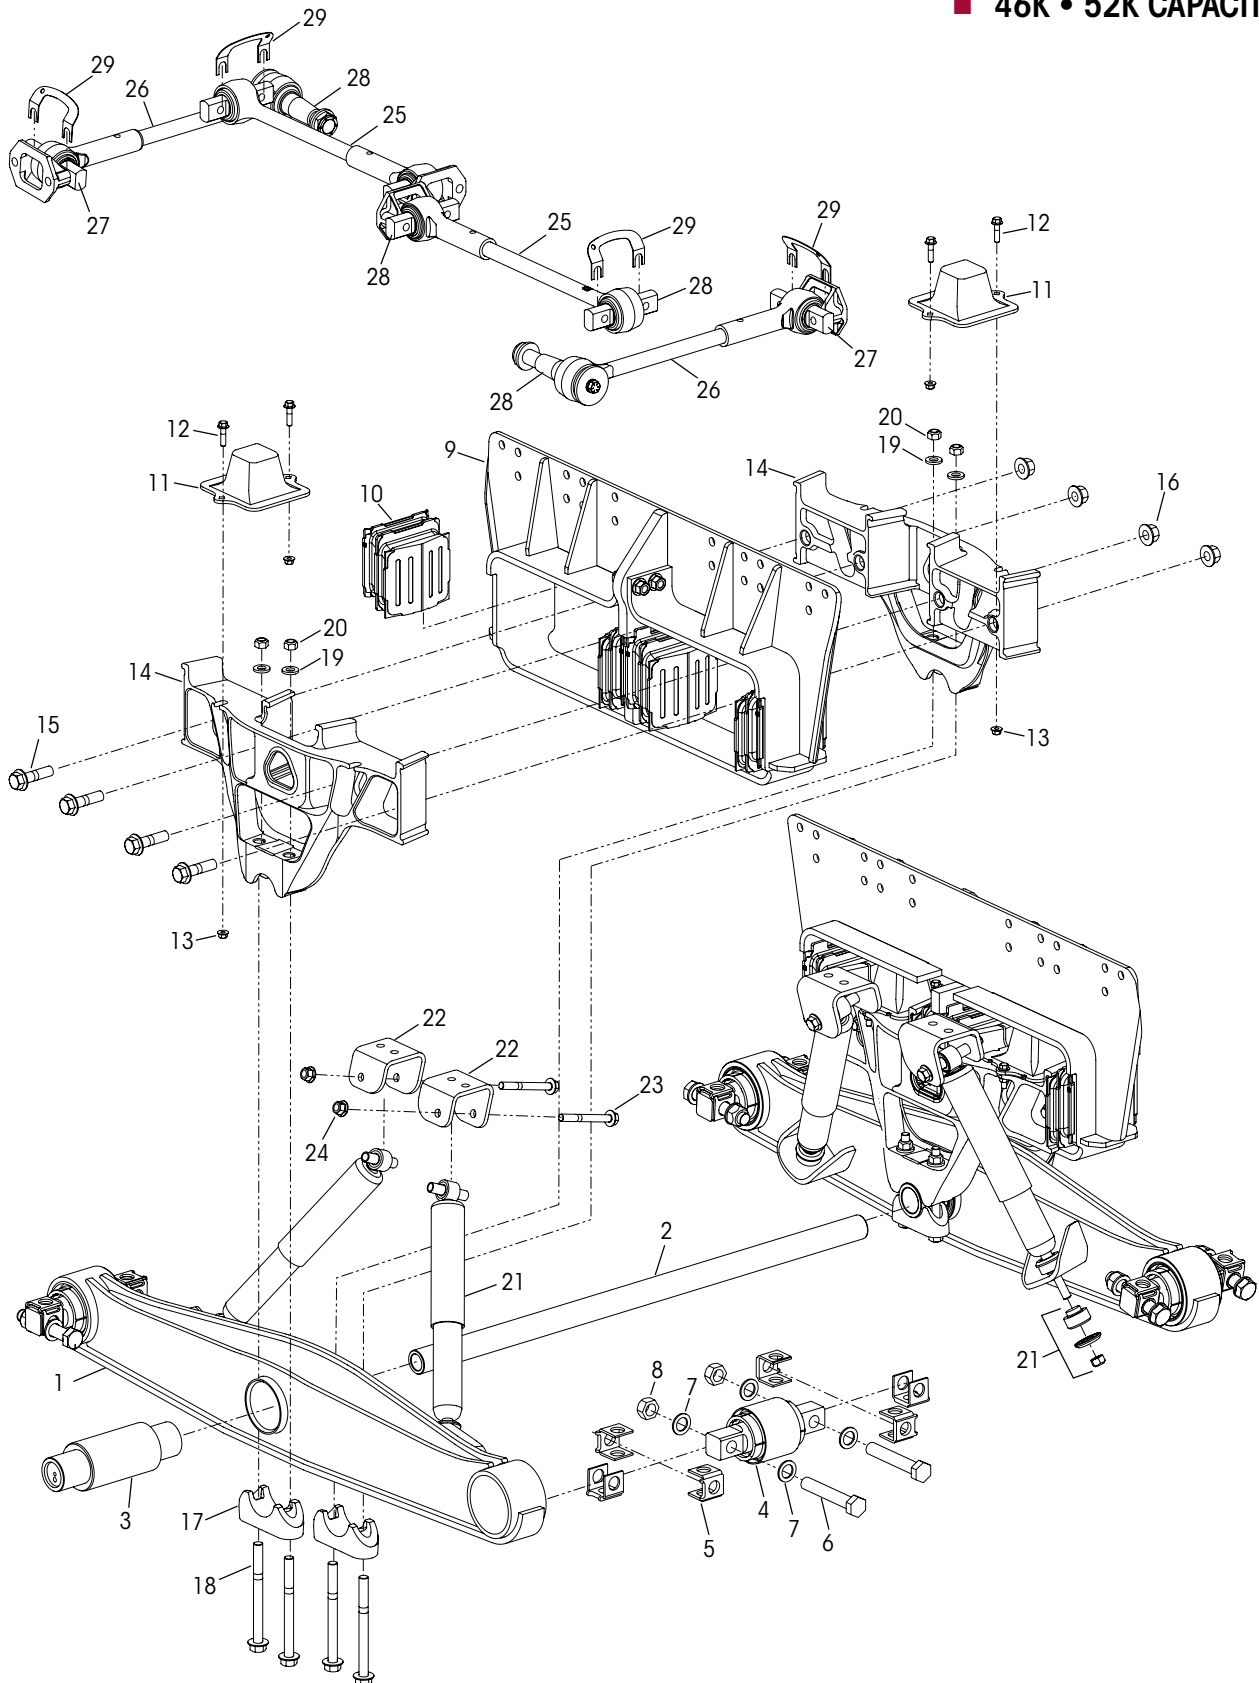
■ 46K • 52K CAPACITY

Hendrickson Lit. No. 48422-592 – ULTIMAAX Gauge Card can be used to measure in unloaded condition (1) the height of the progressive load spring (PLS) and (2) the length of cut/split of the shear spring and PLS. Gauge card can be obtained on-line at www.hendrickson-intl.com/Litform

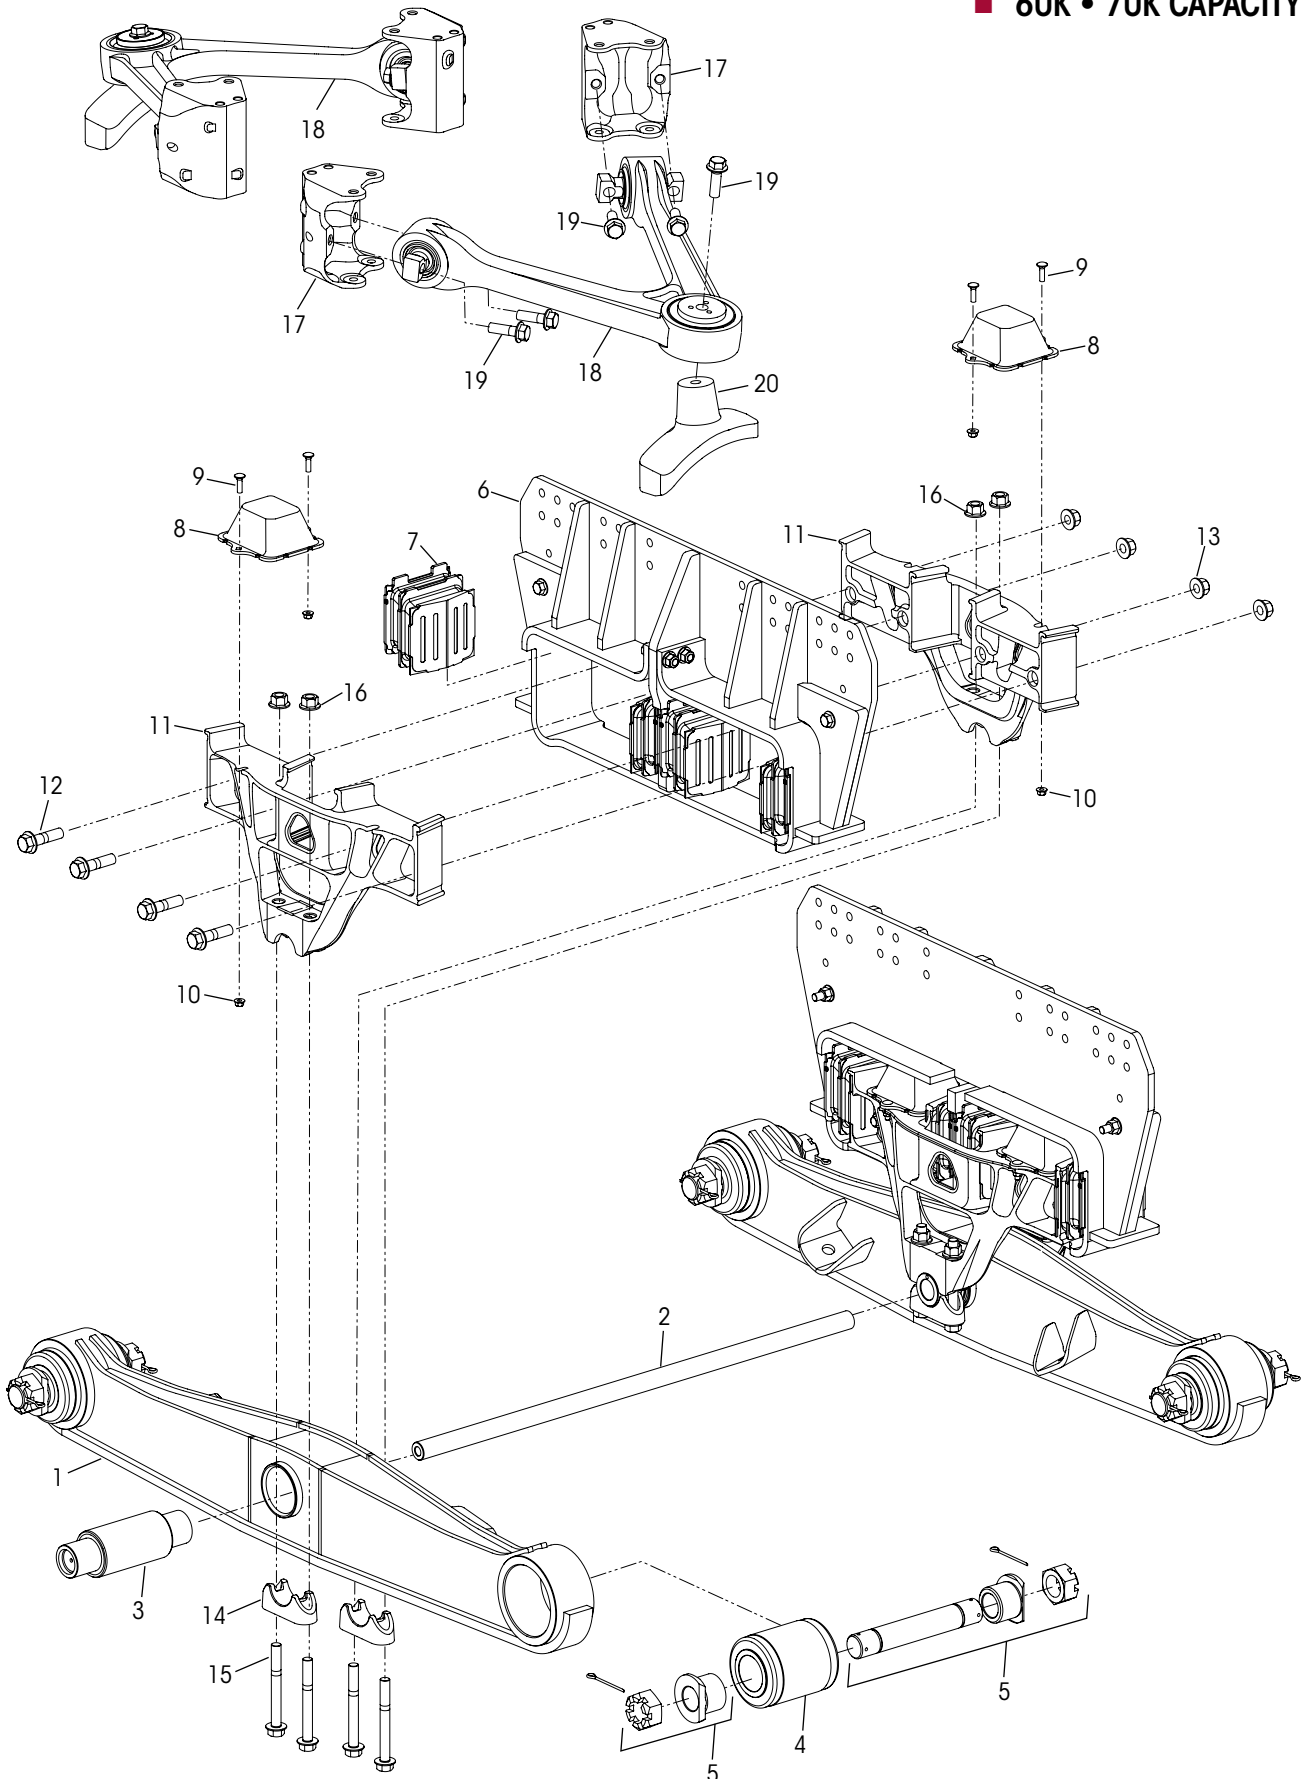
■ 60K • 70K CAPACITY

Hendrickson Lit. No. 48422-598 – ULTIMAAX Gauge Card can be used to measure in unloaded condition (1) the height of the progressive load spring (PLS) and (2) the length of cut/split of the shear spring and PLS. Gauge card can be obtained on-line at www.hendrickson-intl.com/Litform

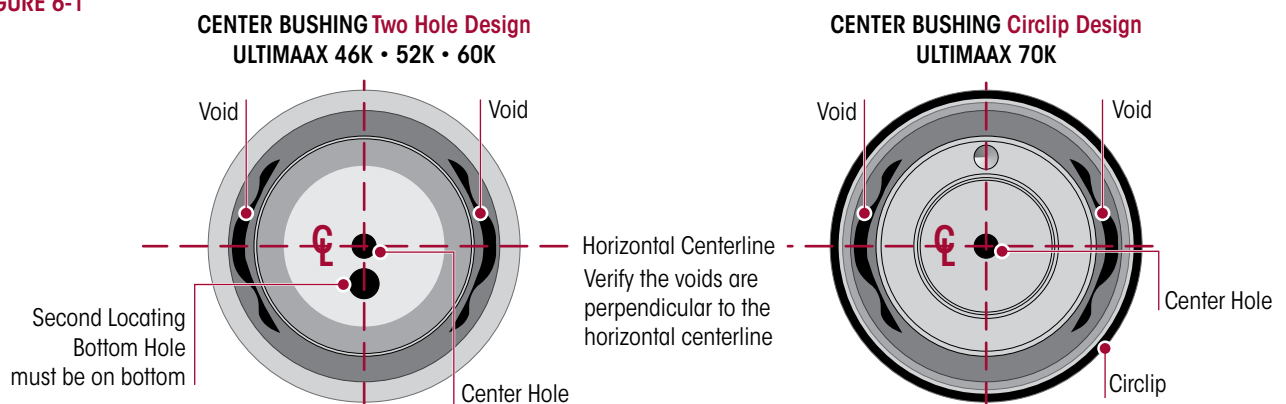
FIGURE 6-1

1. Visually inspect the center bushing for signs of movement or excessive wear such as frayed, bulging or distorted rubber in the center bushing.
2. Replacement is necessary if:
 - Any metal to metal contact is visible.
 - Any signs that the bushing inner metal is not centered in the bushing.
 - Any equalizing beam to saddle contact.

An inspection of the center bushing is necessary **when a vehicle is in the shop for major repair work** and at regular preventive maintenance intervals.

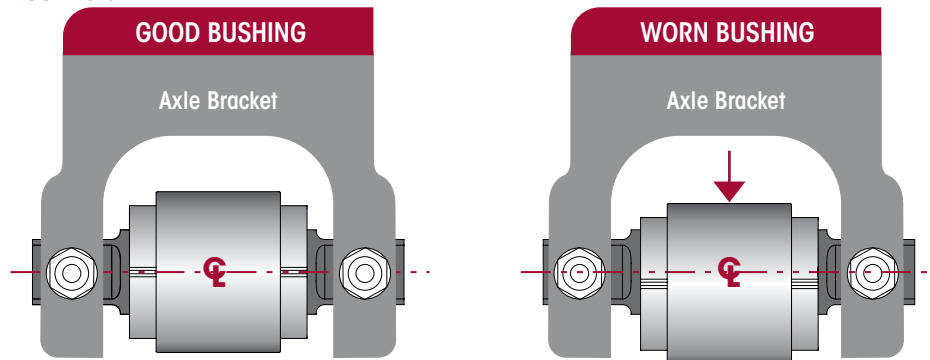
FIGURE 6-3

A **GOOD** bushing will result in the equalizing beam end hub appearing to be **centered** with the centerline of the end bushing in the axle bracket

A **WORN** bushing will result in the equalizing beam end hub appearing to be **5/8" (15 mm) offset/below** the centerline of the end bushing in the axle bracket

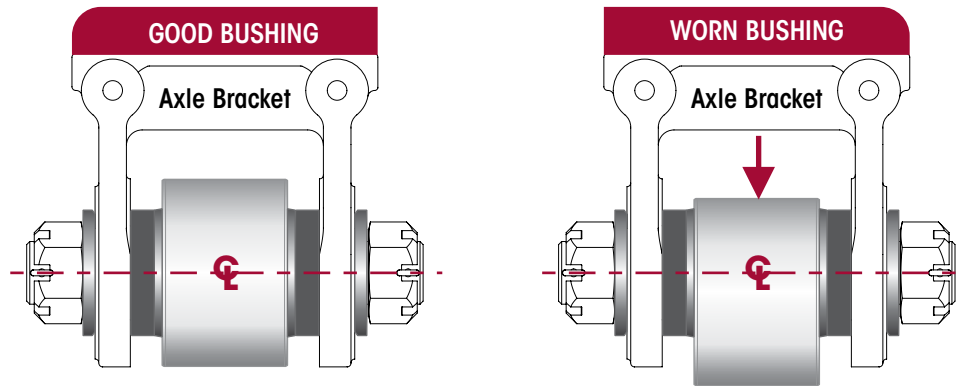
FIGURE 6-6

A **GOOD** bushing will result in the equalizing beam end hub appearing to be **centered** with the centerline of the end bushing in the axle bracket

A **WORN** bushing will result in the equalizing beam end hub appearing to be **5/8" (15 mm) offset/below** the centerline of the end bushing in the axle bracket

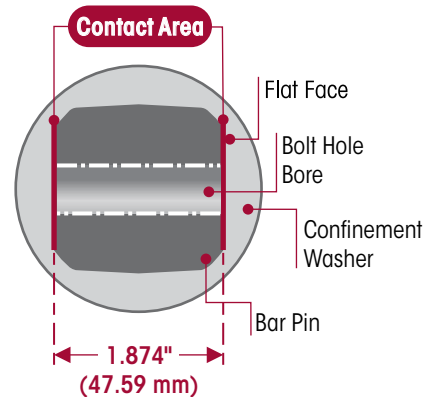
FIGURE 6-10
Shim Type Bar Pin End Bushing

If bar pin measurement is **less than 1.874" (47.59 mm)**, replacement is required.

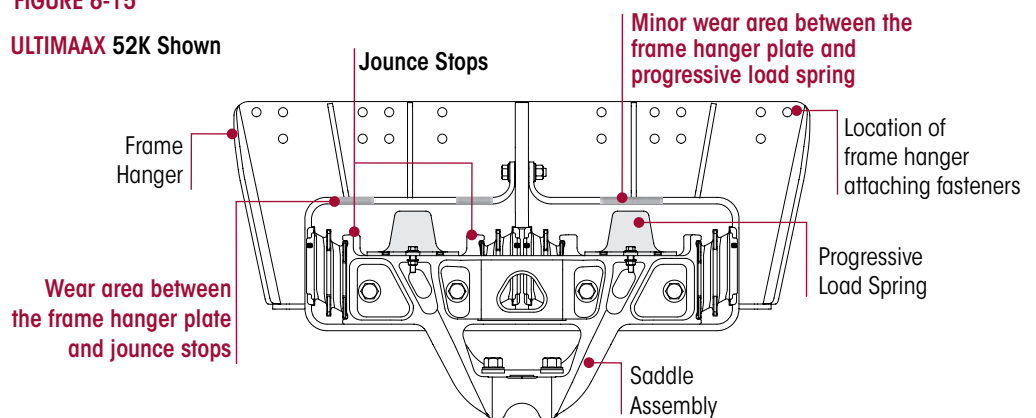
FIGURE 6-15

ULTIMAAX 52K Shown

- Inspect the frame hanger for any damage, cracks or signs of adverse or abrasive contact with other components. Some minor wear will be evident where the progressive load spring contacts the frame hanger assembly, see Figure 6-15. If more than half the thickness of the frame hanger plate is damaged or cracked, replace the frame hanger assembly.
- Look for wear in the frame hanger cavity due to contact with the jounce stop, see Figure 6-15. If more than half the thickness of the frame hanger plate is worn or damaged, replace the frame hanger.
- Inspect the frame hanger attaching fasteners and frame hanger assembly for signs of looseness or movement. Re-tighten any loose fasteners to specified torque. Components damaged by loose fasteners must be replaced.

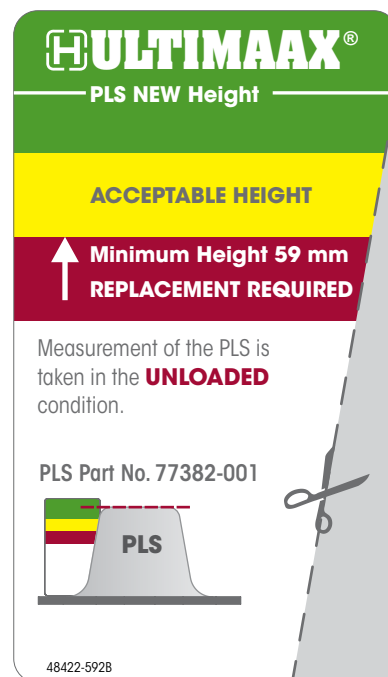
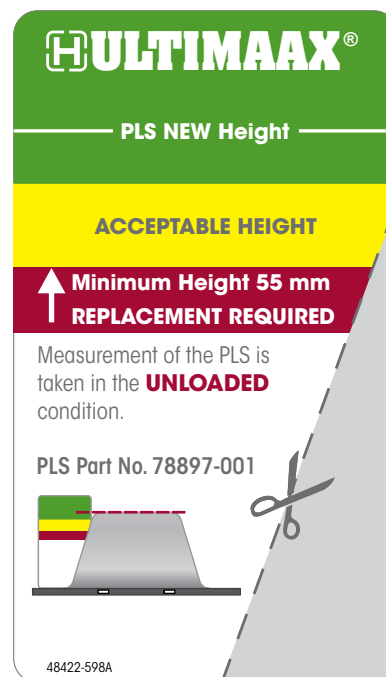
FIGURE 6-21

Always inspect the progressive load spring with the vehicle in the **UNLOADED** condition.

- The height of a **new** PLS is:
48K•52K – 3½" (78 mm) • **60K•70K** – 2⅞" (73 mm)
- The PLS requires replacement if the height is below, see Figure 6-22:
48K•52K – 2⅝" (59 mm) • **60K•70K** – 2¾" (55 mm)

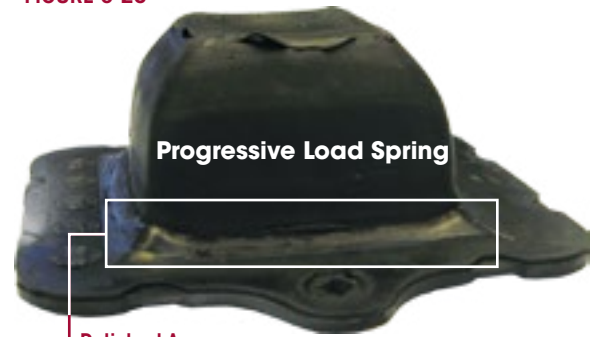
- A bent or cracked mounting base requires PLS replacement.
- If any cuts or splits in the rubber of over 2" (50 mm) in length and an average depth of ½" (13 mm), the effected PLS requires replacement. A certain amount of gradual breakup of the rubber surface is normal. The most likely areas for potential cuts, splits, or wear are shown in Figure 6-22 as "//////".
- If any bonding separation depth of the rubber from the PLS mounting base plate surface (see Figure 6-22) is more than ½" (13 mm), the effected PLS requires replacement.
- Creases formed by folding of the rubber surface under load are acceptable. These appear as stripes on the surface, polished by wear or covered with tacky rubber, see Figure 6-23.

Polished Appearance —
 Creases formed by the folding of the rubber surface under load are acceptable.

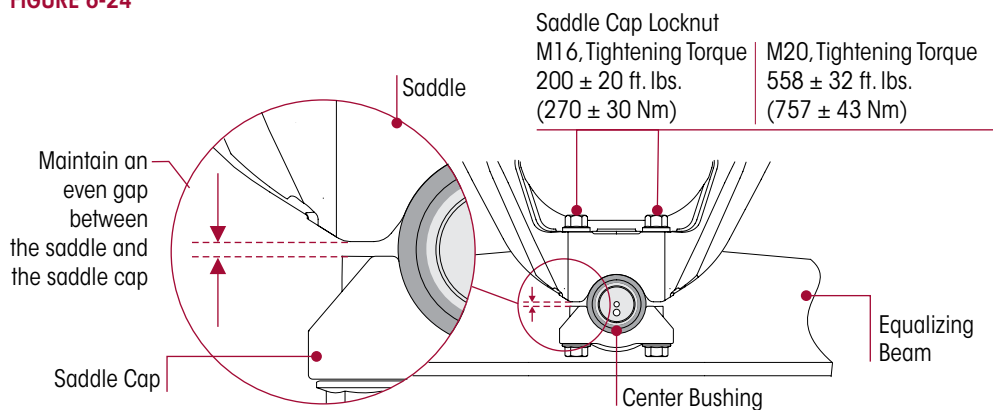
FIGURE 6-24

Visually inspect for any signs of movement or looseness and ensure:

- Each saddle is centered on each equalizing beam center bushing.
- The center bushing inner metal is full seated to the saddle.

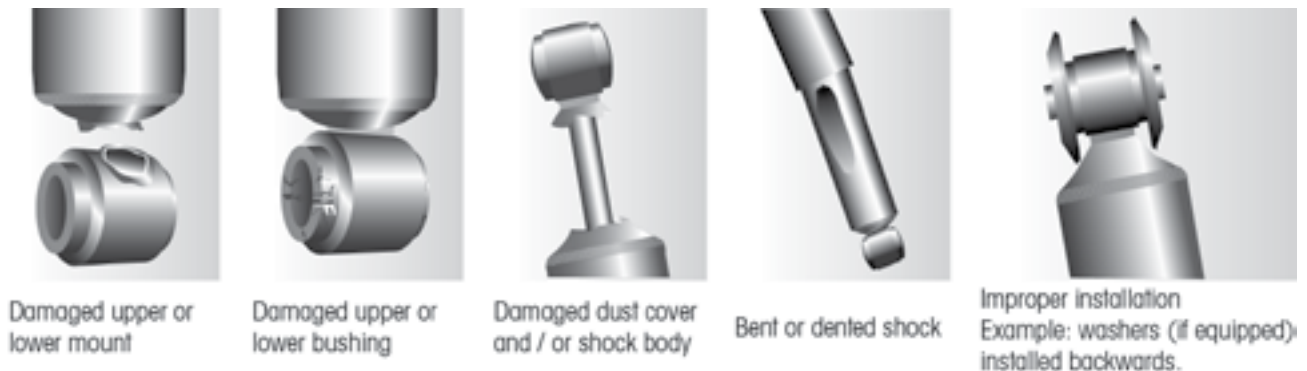
SHOCK ABSORBER VISUAL INSPECTION - UNACCEPTABLE CONDITIONS

Look for any of the potential problems shown in Figure 6-28 when doing a visual inspection. Inspect the shock absorbers fully extended. Replace as necessary.

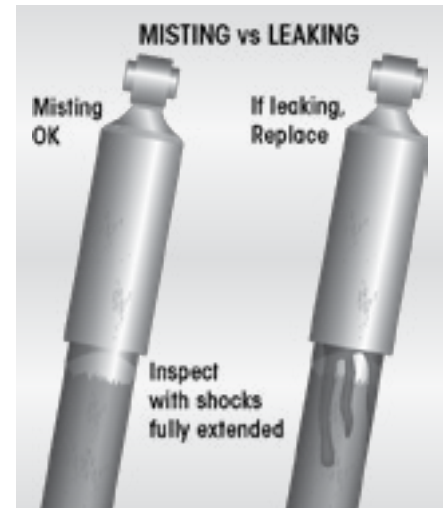
FIGURE 6-29

The inspection must not be conducted after driving in wet weather or a vehicle wash. Shocks need to be free from water. Many shocks are often misdiagnosed as failures. Misting is the process whereby very small amounts of shock fluid evaporate at a high operating temperature through the upper seal of the shock, see Figure 6-29. When the "mist" reaches the cooler outside air, it condenses and forms a film on the outside of the shock body. Misting is perfectly normal and necessary function of the shock. The fluid, which evaporates through the seal area helps to lubricate and prolong the life of the seal.

A shock that is truly leaking and needs to be replaced will show signs of fluid leaking in streams from the upper seal. These streams can easily be seen when the shock is fully extended, underneath the main body (dust cover) of the shock. Look for these potential problems when doing a visual inspection. Inspect the shock absorbers fully extended. Replace as necessary.

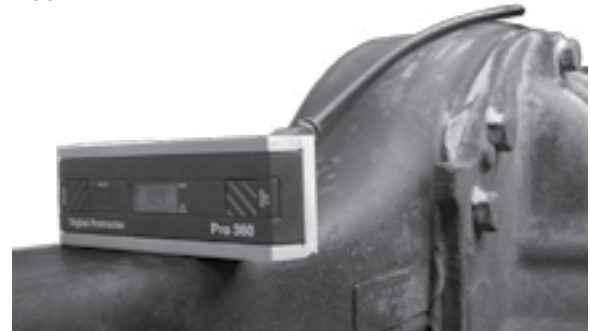
FIGURE 7-1

1. Use a work bay with a level floor.
2. Relax the suspension by slowly moving the vehicle back and forth several times in a straight line without using the brakes. This will slacken or loosen the suspension as the vehicle is positioned. End with all wheels positioned straight ahead. Roll to a stop without the brakes being applied. **DO NOT** set the parking brake.
3. Chock the front wheels of the vehicle.
4. Place a digital protractor on the axle housing as shown in Figure 7-1.
5. Check to see if the pinion angle is correct per the vehicle manufacturer's specified range.
6. If necessary, add/remove shims at the longitudinal torque rod connections as required to achieve the proper pinion angle.
7. When the pinion angle is correct tighten all fasteners to the proper torque specifications per the vehicle manufacturer and recheck the pinion angles.
8. Remove wheel chocks.

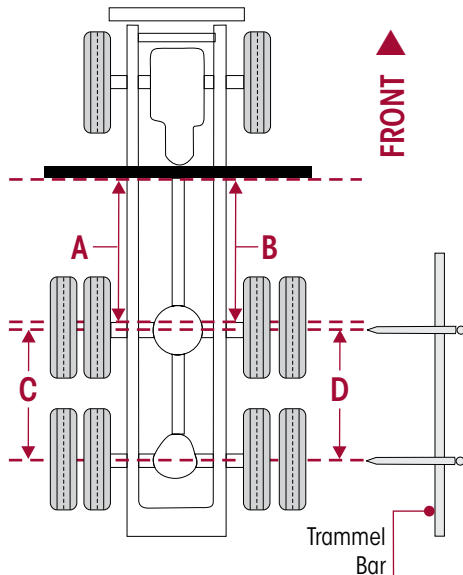
FIGURE 7-2

1. Use a work bay with a level, flat surface.
2. Relax the suspension by slowly moving the vehicle back and forth several times in a straight line. This will slacken or loosen the suspension as the vehicle is positioned. End with all wheels positioned straight ahead.

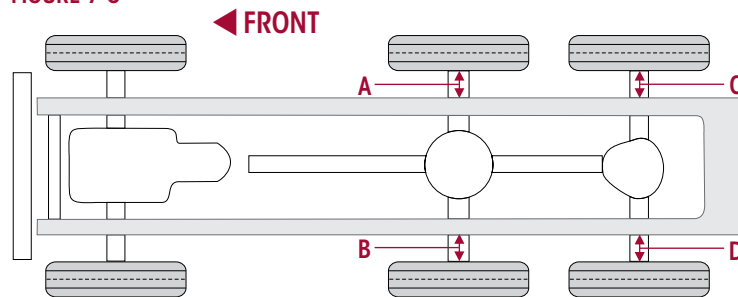
FIGURE 7-3

6. Verify the axle lateral alignment is within the vehicle manufacturer's specifications. Adding or removing shims that are located between the transverse torque rod and the frame rail will normally correct the axle lateral alignment.
 - A general rule of thumb is to use a torque rod shim with a thickness that is half of the difference between the two measurements.

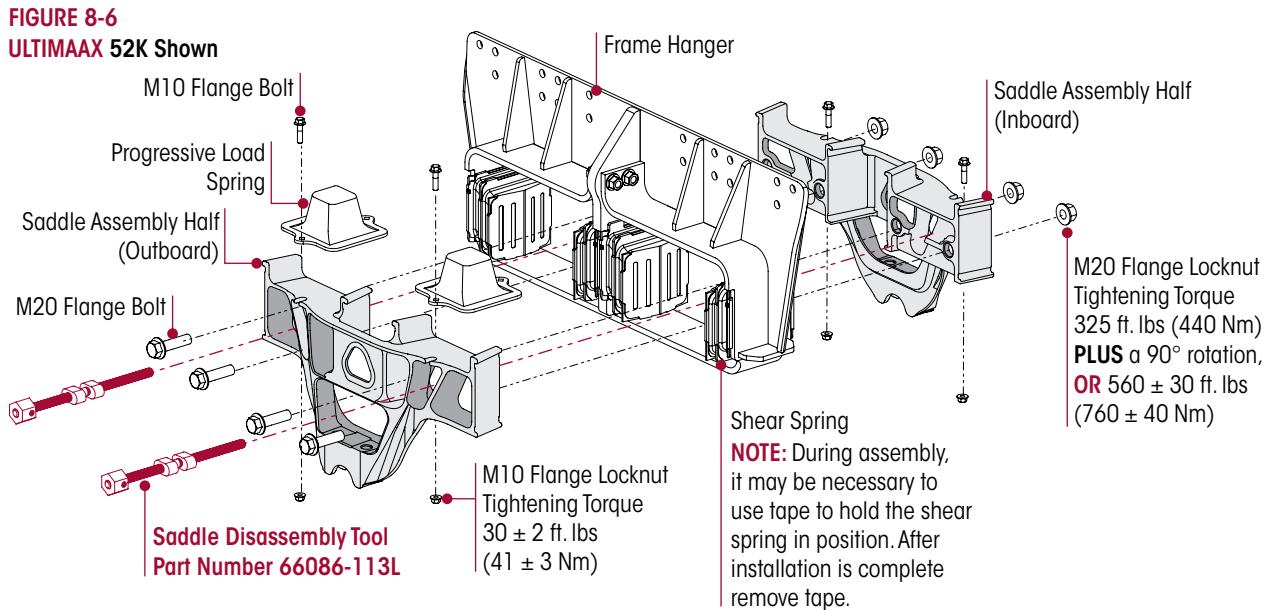
12. To separate the two saddle halves, evenly rotate the threaded rod nut to tighten the Saddle Disassembly Tool, see Figure 8-6.

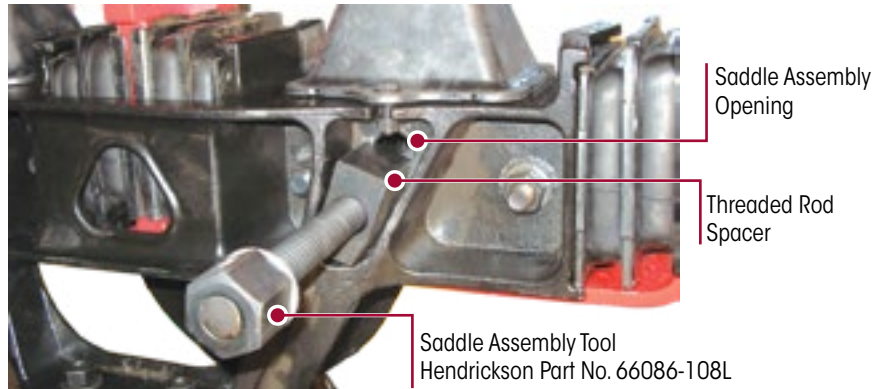
FIGURE 8-10

6. On each side of the saddle assemblies, rotate the threaded rod spacers and spacer nuts of the saddle assembly tool until each are oriented properly into the saddle assembly openings, see Figure 8-10.

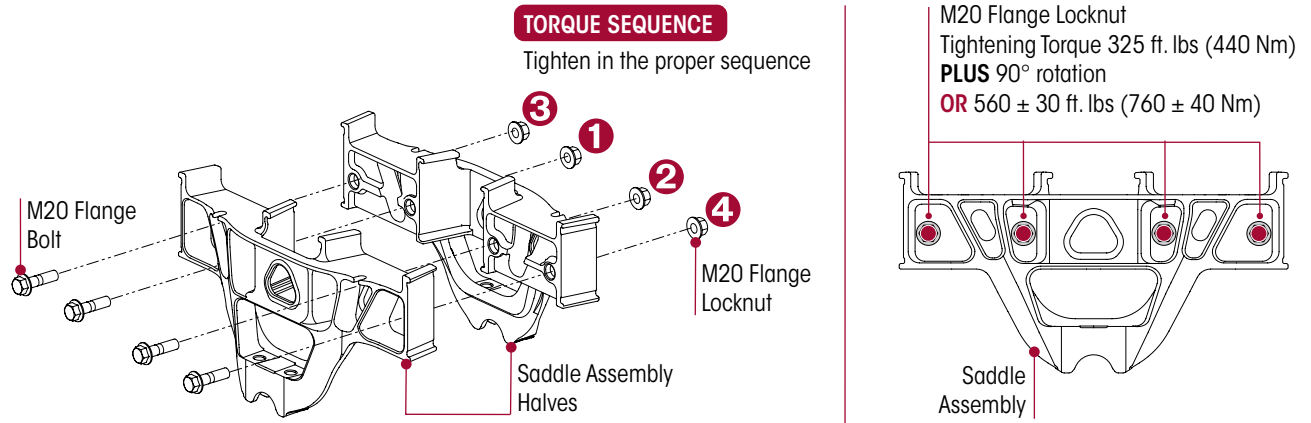
FIGURE 8-12

9. Install the new M20 saddle fasteners. Tighten in the proper sequence shown in Figure 8-12 to 325 foot pounds plus a 90° rotation, or 560 ± 30 foot pounds torque.
10. Remove temporary tape from the shear springs if used during assembly.
11. Remove the Saddle Assembly Tool.
12. Install the progressive load springs.
13. Install the progressive load spring M10 fasteners. Tighten to 30 ± 2 foot pounds torque.
14. Remove the frame supports.
15. Lower the frame of the vehicle while engaging and centering the saddles on the equalizing beam's center bushings, see Figure 8-13.

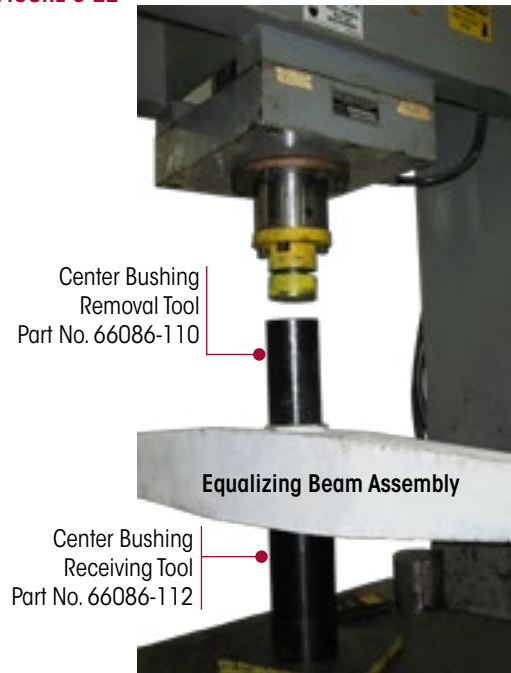
2. Place the equalizing beam assembly in a shop press with the center hub firmly supported on the receiving tool or on the press, see Figure 8-22.
3. Install the center bushing removal tool, ensure it is centered on the center bushing.
4. Push directly on center bushing removal tool until the center bushing is pressed out of the equalizing beam bore, see Figure 8-22.
5. Inspect the beam bore.

After removing the center bushing, thoroughly inspect the beam bore. If damaged, replace with a new equalizing beam. **DO NOT** attempt to re-bush or use an equalizing beam that has been damaged.

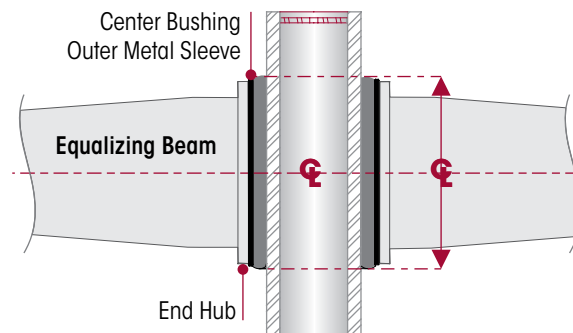
FIGURE 8-26

Press the center bushing until the center bushing **outer metal sleeve** is centered in the equalizing **beam end hub**.

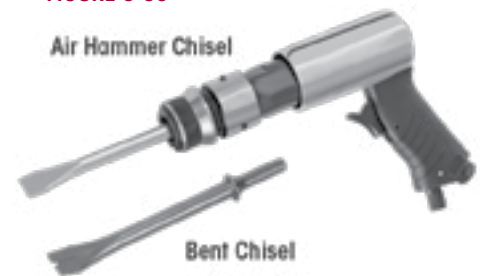
ADAPTER STYLE END BUSHING – ULTIMAAX 60K•70K
FIGURE 8-35
You will need:

- A shop press with a capacity of at least 100 tons
- Air hammer / chisel / Bent chisel, see Figure 8-35
- Hendrickson Part No. 66086-101 (OTC Part No. 1763), see Special Tools Section of this publication

5. Support the end of the equalizing beam as it may drop when the other adapter is removed.
6. Remove remaining adapters.
7. When the adapter has enough clearance between the axle bracket and the adapter flange, use a bent chisel as shown in Figure 8-35 to wedge and force the adapter out.

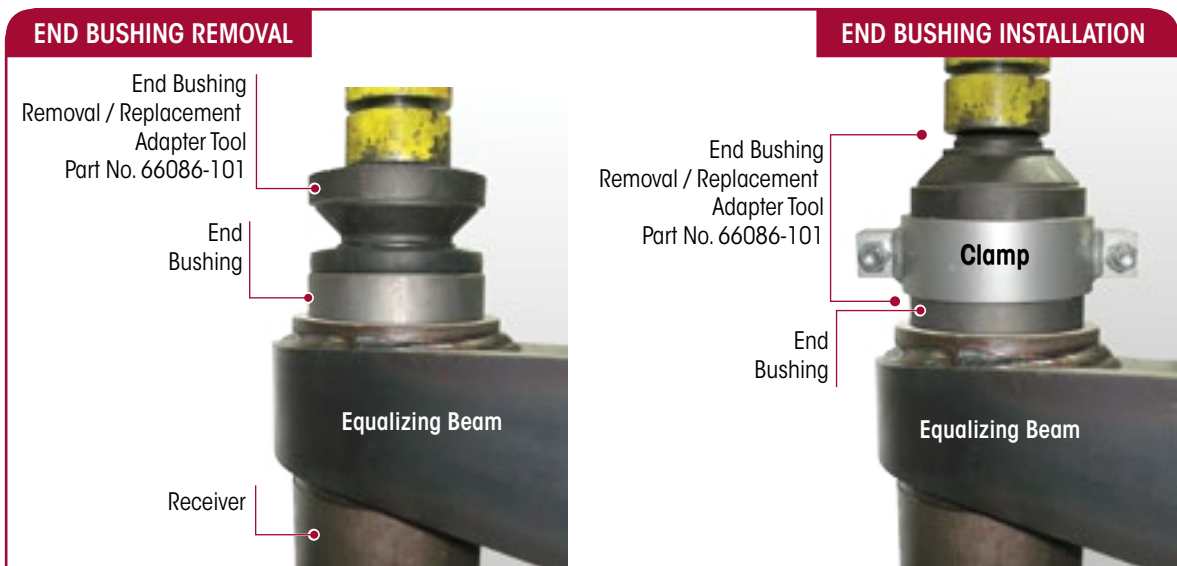
FIGURE 8-39

1. Clean the end bushing bore with a cylinder ball hone or emery paper. Clean any debris.
2. Lubricate the equalizing beam bore and the equalizing beam center bushing outer metal sleeve with an NLGI#2 – EP (Extreme Pressure) grease, see Figure 8-40.
3. Position the end bushing removal / replacement adapter, with the tapered end facing away from the new bushing, onto the clamp, see Figure 8-39.
4. Wrench tighten the clamp onto the bushing and the adapter as shown in Figure 8-39.

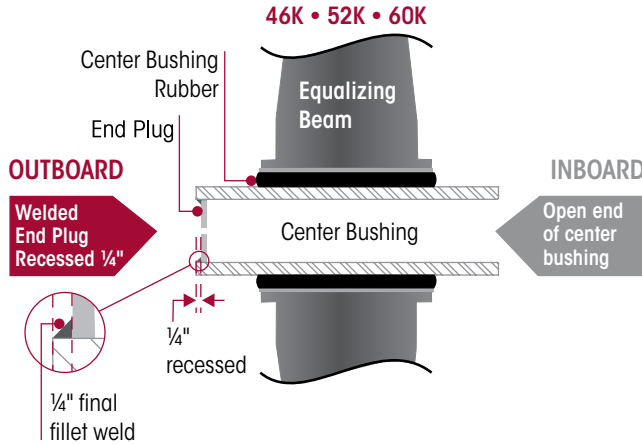
FIGURE 8-46

4. Remove the cut section of the cross tube and slide the remaining sections out of the center bushings and discard.
5. Remove only one center bushing end plug from the suspension:
 - **46K • 52K • 60K** – Use a 2" (50.8 mm) hole saw, see Figure 8-46
 - **70K** – Remove circlip, see Figure 8-47

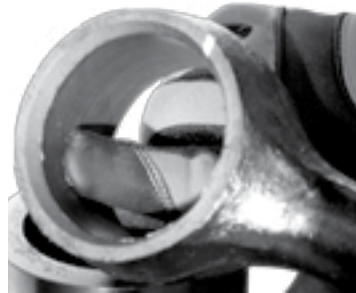
FIGURE 8-53

Apply NLGI #2-EP (Extreme Pressure) lubricant to the inner diameter of torque rod end hub and bushings

2. Lubricate the inner diameter of the torque rod end hubs and the outer metal of new bushings with NLGI #2 EP grease, see Figure 8-53.
